#### DEPARTMENT OF TRANSPORTATION

## WELDING INSPECTION REPORT

OSM Arrival Time: 1900 **Project Name:** SAS Superstructure **OSM Departure Time:** 700 **Prime Contractor:** American Bridge/Fluor Enterprises, a JV

34-0006 **Bridge No: Component: OBG** Components

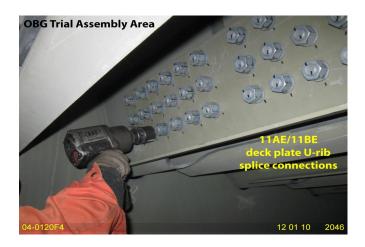
ZPMC workers performing what appeared to be final tightening of ASTM A325M bolt sets on deck plate U-rib/splice plate connections at the 11AE/11BE transverse joint using an air impact gun. See photo below. Each bolt set observed appeared to have been marked at the snug-tight phase of tightening in conformance with contract documents.
